SBIR N211-038

Phase 1 Supplementary Data

Laminated Bus Bar Issues - Cracking

Laminated Bus Bar Issues – Internal Failure

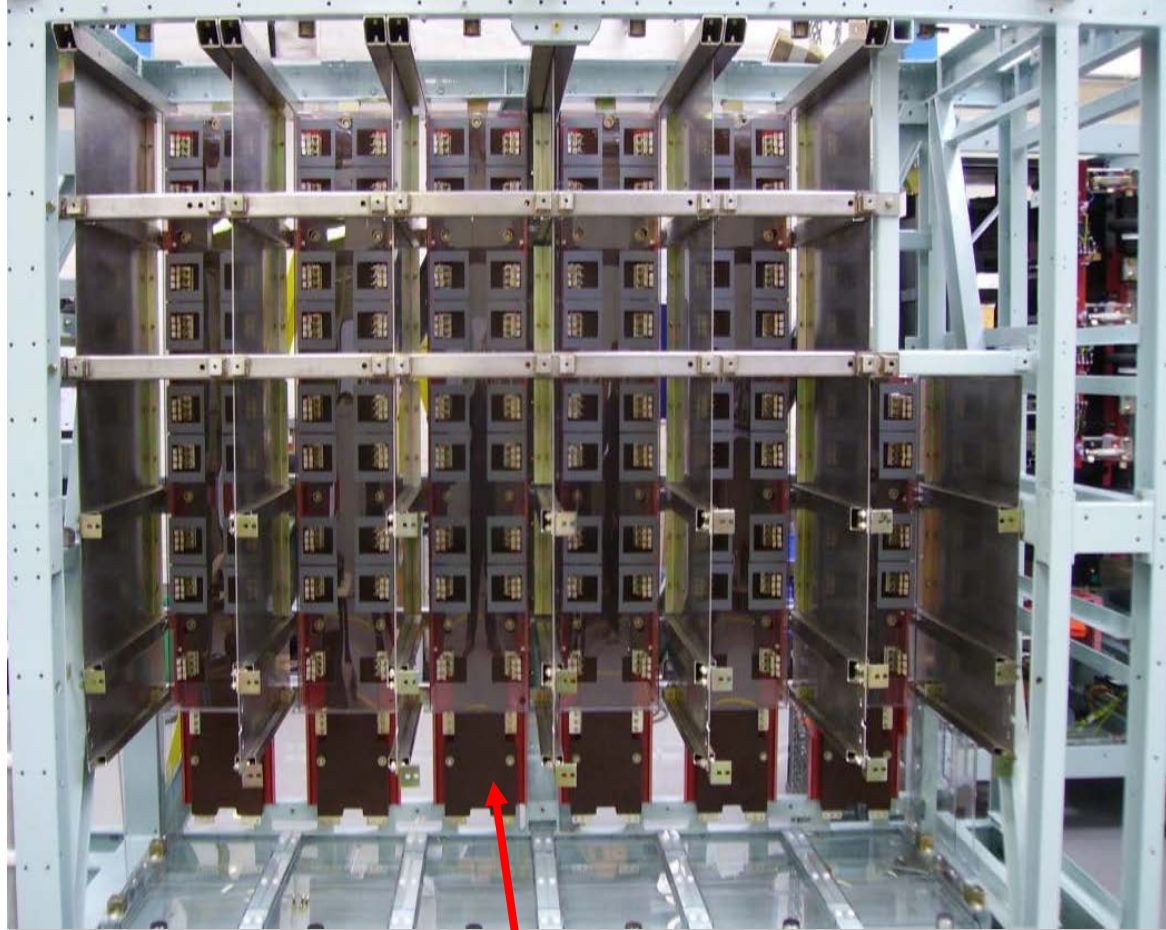
Example of DDG1000 Laminate Bus Bar

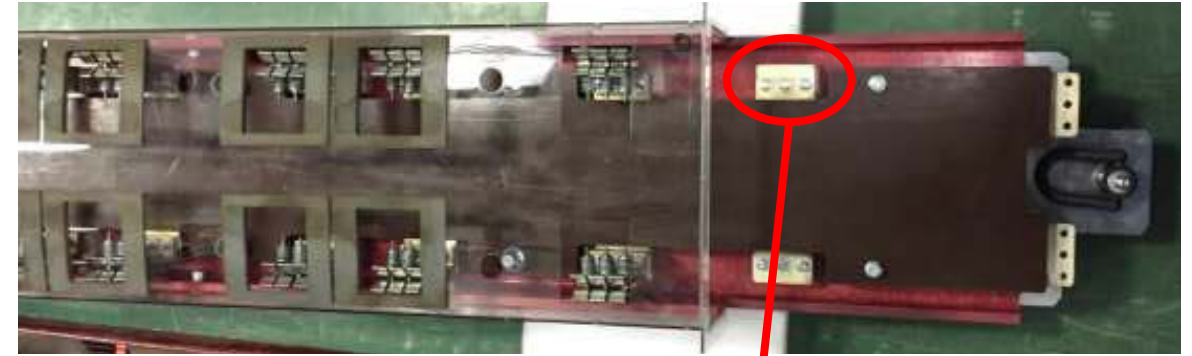
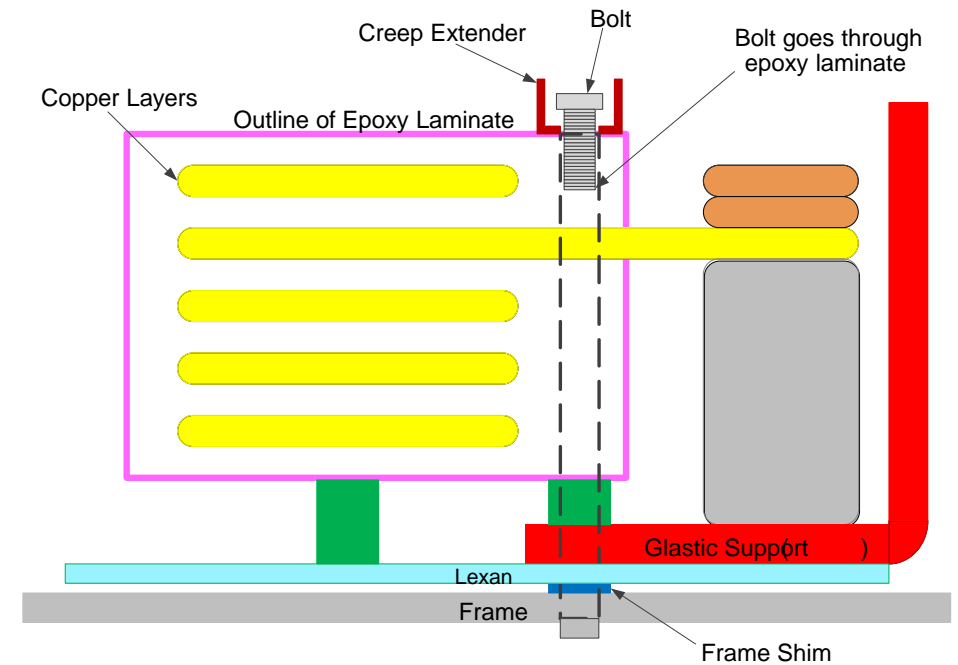
Additional Bus Bar assembly mounts overtop the 6 seen above

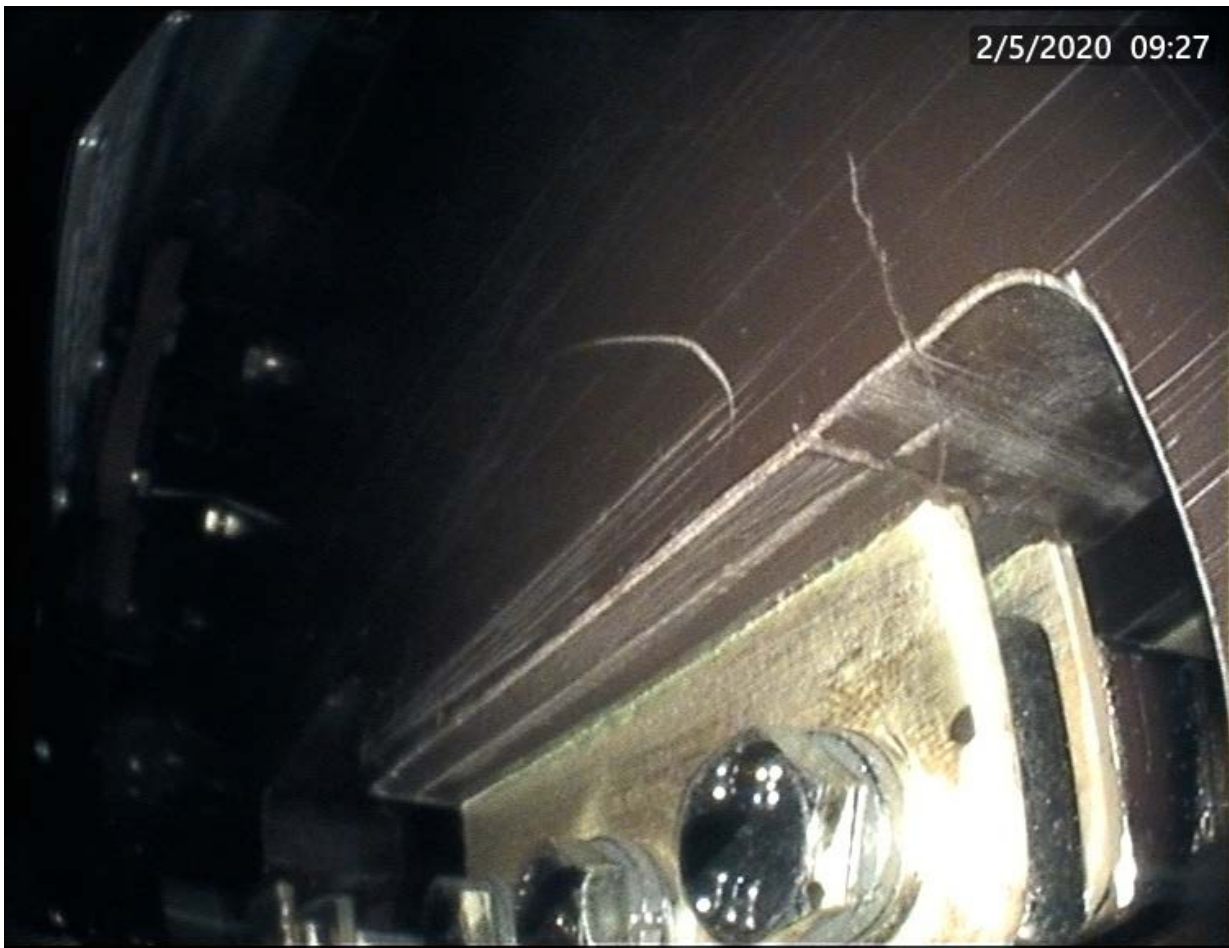
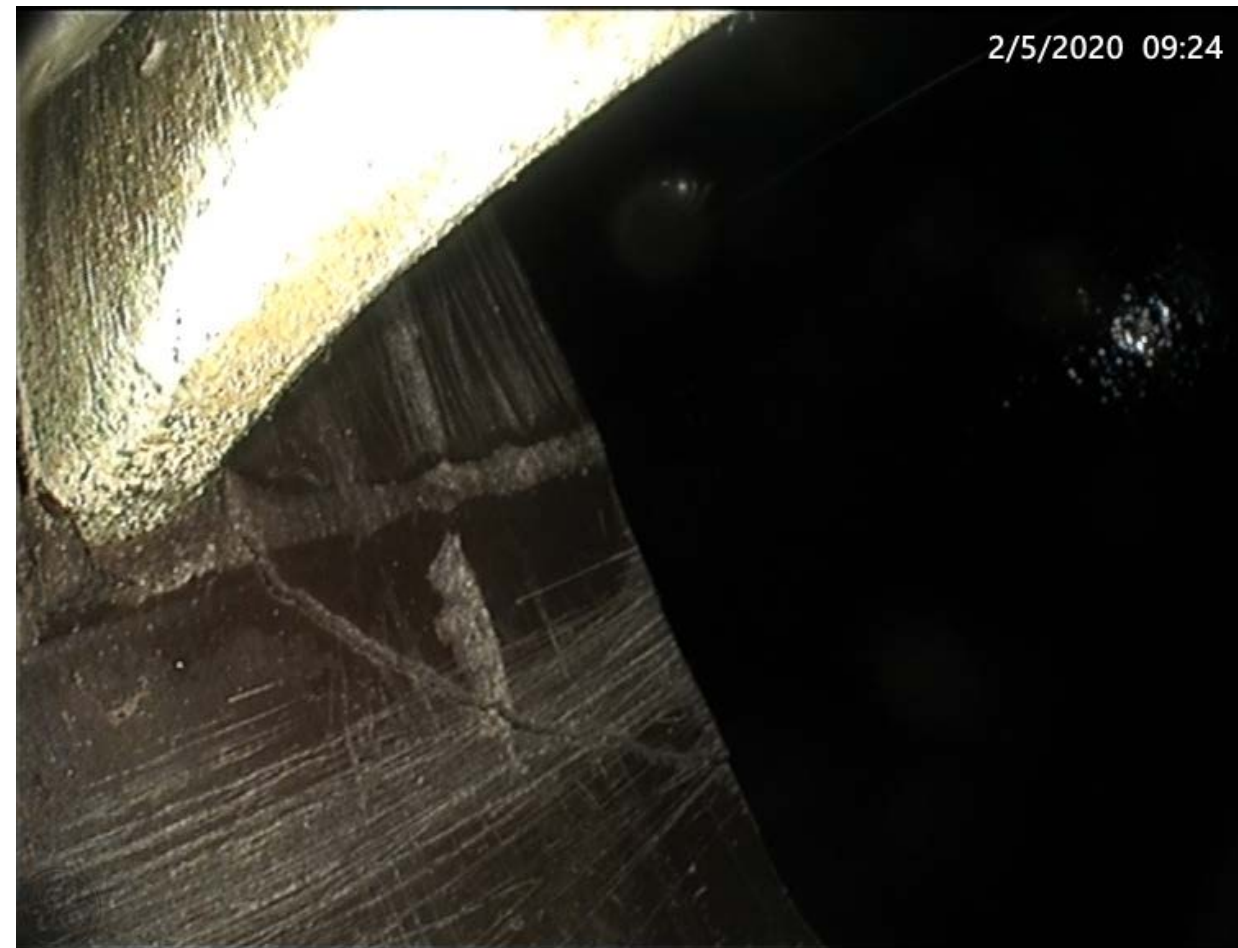
Bus Bar Issues - Cracking

- **In certain cases, Laminated bus bars in use on the DDG1000 program have been shown to develop cracks due to installation environment.**
 - Primary Root Cause = Stresses from irregular mounting surfaces and alignment with adjoining electrical interfaces often results in bus bar cracking.
- **Examples of bus bar cracks extending across multiple copper layers can be seen on the next slide.**
 - Are their materials or design methods which could be employed to reduce the probabilities of stress induced cracks from forming?

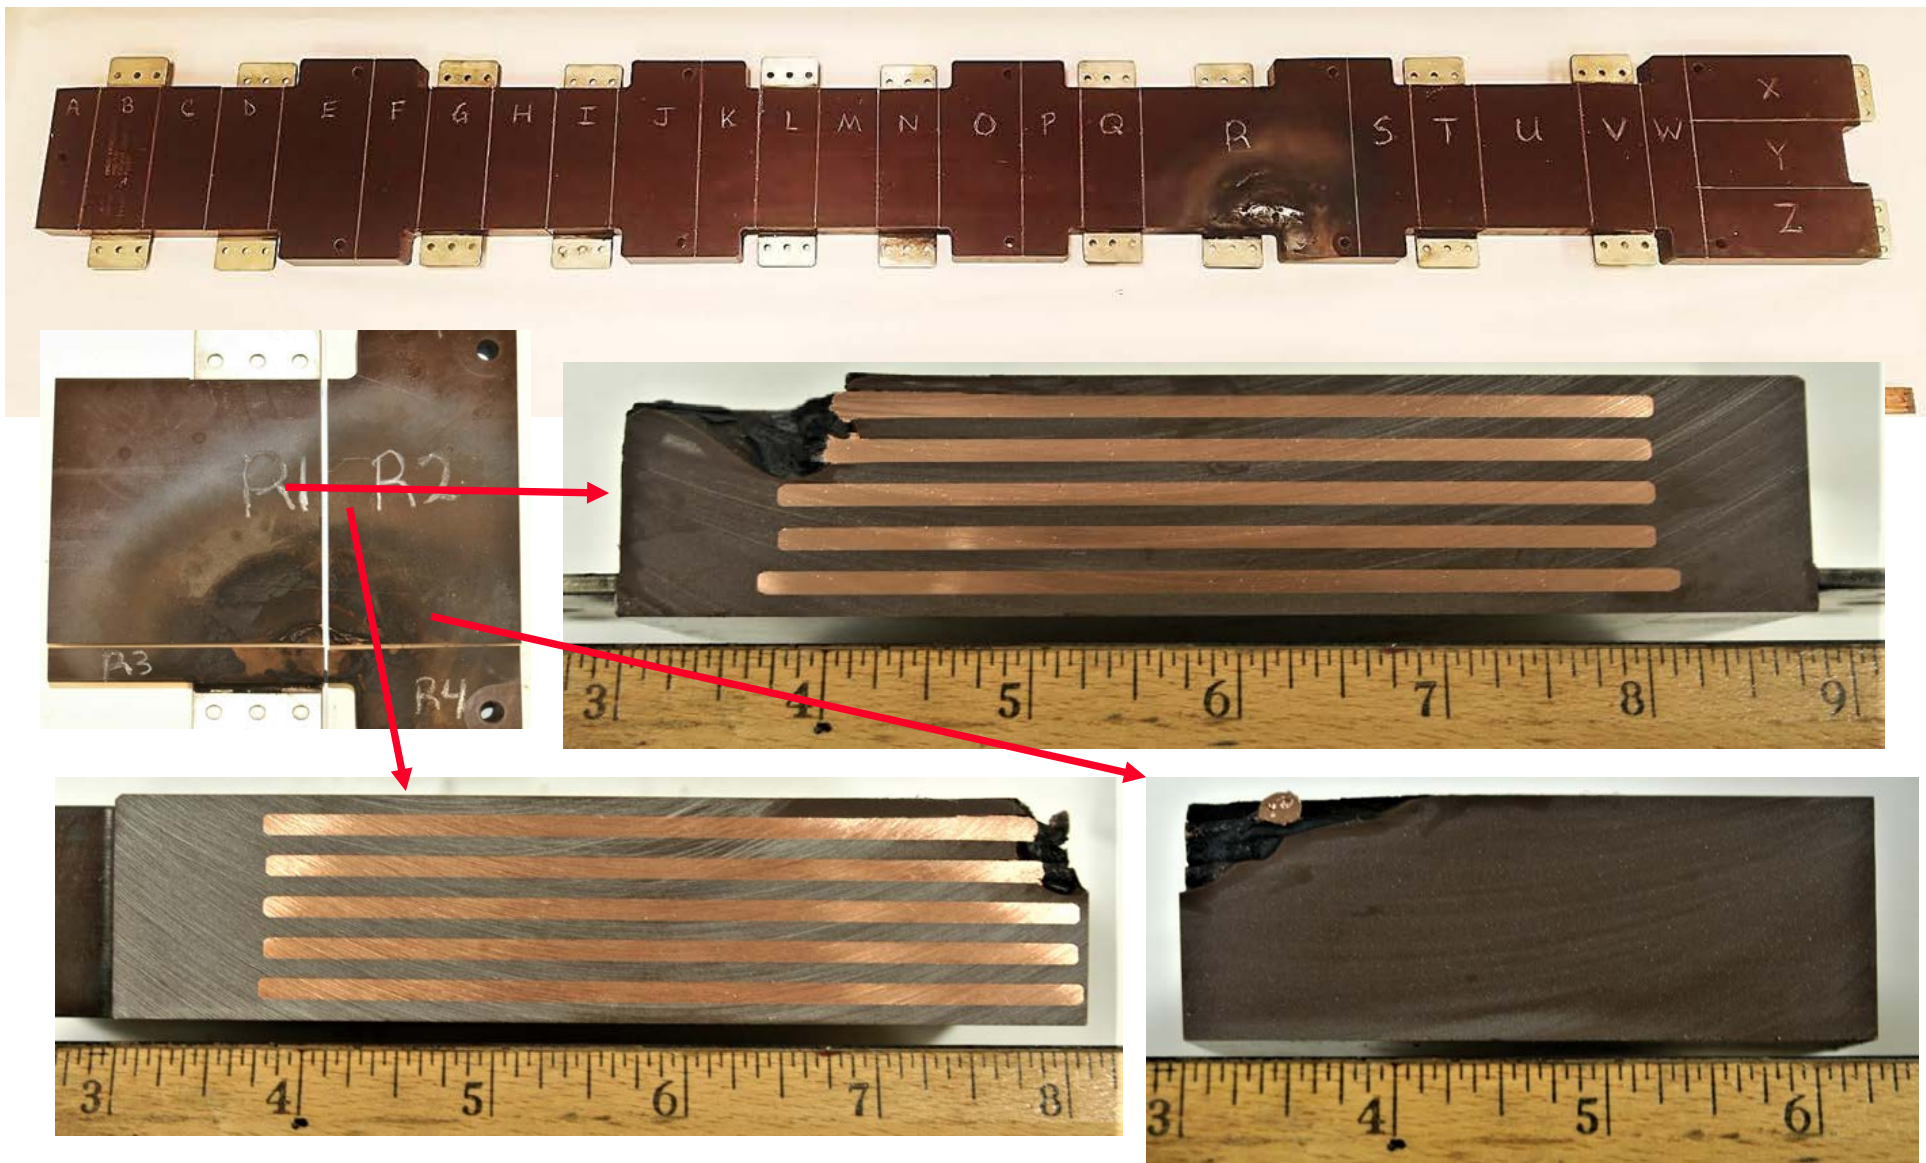
Bus Bar Issues – Internal Failure

- **Bus bar failure seen on the following slides had failed shortly after being in service and had passed all established factory test criteria.**
 - Sectioning of additional bus bars from the same lot revealed the presence of contamination/voids that was not detected by OEM. It has been assumed that similar contamination/voids likely caused the failure seen.
 - OEM used partial discharge and tan-delta testing to assess layer to layer insulation integrity prior to shipment.
- **What alternative/enhanced NDT tests could have detected anomalies within the insulation system?**
 - Factory tests? Shipboard in service tests?
